Contract #: 04-0120F4Cty: SF/ALA Rte: 80 PM: 13.2/13.9File #: 69.28**WELDING INSPECTION REPORT****Resident Engineer:** Pursell, Gary**Address:** 333 Burma Road**City:** Oakland, CA 94607**Report No:** WIR-002656**Date Inspected:** 26-May-2008**Project Name:** SAS Superstructure**OSM Arrival Time:** 1400**Prime Contractor:** American Bridge/Fluor Enterprises, a JV**OSM Departure Time:** 2300**Contractor:** Zhenhua Port Machinery Company, Ltd (ZPMC), Changxing Island **Location:** Shanghai, China

Bridge No: 34-0006**Component:** OBG side and bottom panels and tower skin p**Summary of Items Observed:**

WELDING INSPECTION REPORT

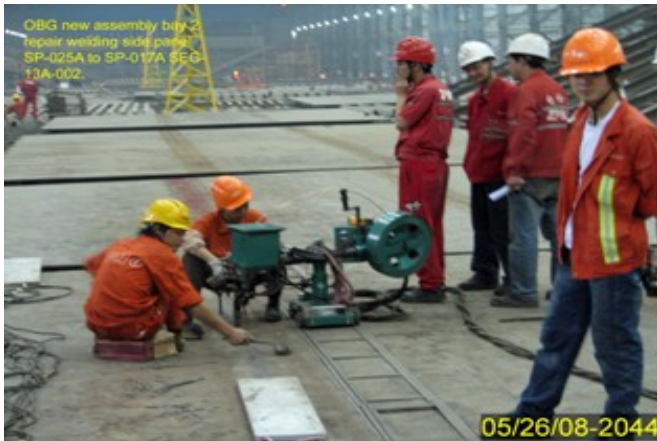
Other general observations in the New Tower bays include ZPMC tack welding tower skin plates, weld bevel preparation, flame straightening, CNC parts cutting, hole drilling and grinding.
